**Hoh River Miles 17 to 40: Oxbow Canyon and Mount Tom Creek**

**July 2004**

# **Summary Report for Geomorphic Assessment of Hoh River in Washington State**

## **River Miles 17 to 40 between Oxbow Canyon and Mount Tom Creek**

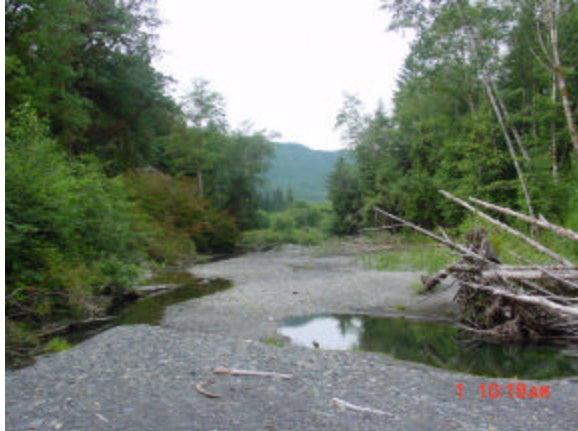
Overflow channels are common in this reach (figure 6). These channels may receive water only through groundwater connections during low flow periods, but they may convey a portion of flood flows at higher discharges. These channels often have woody debris throughout them which can create small backwater pools.

**Figure 6. Looking downstream into overflow channel just downstream of confluence with South Fork along left side of HCMZ. Photograph taken by Reclamation in August 2002.**

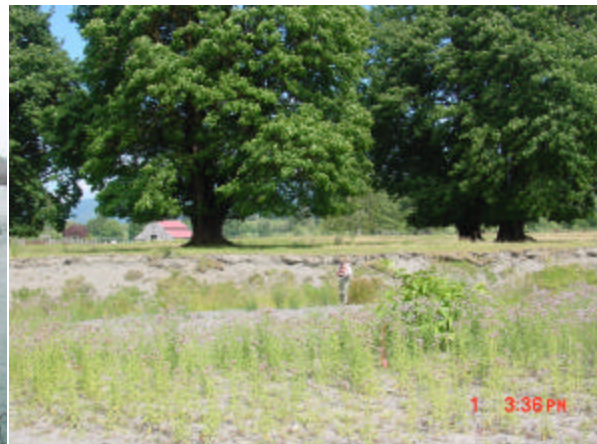
**Figure 8. Huelsdonk Ranch is a historical homestead that is located along the left side of the HCMZ in Reach 5. Photograph taken in August 2002.**

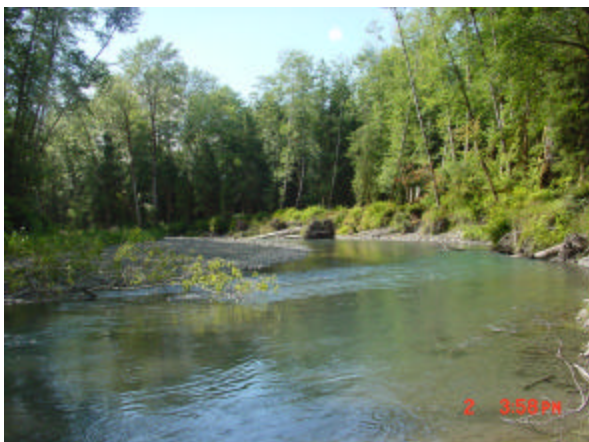
**Figure 11. Elk Creek Side Channel in Reach 8 has a significant surface water connection with the main channel. Photograph taken by Reclamation in August 2002.**
